Manhole Inspection Summary

Manhole # S29AA2003MH

Inspection ☐ Is Incomplete Rating: **4) Poor**

Location Address: **106 NORTHERN PKWY**

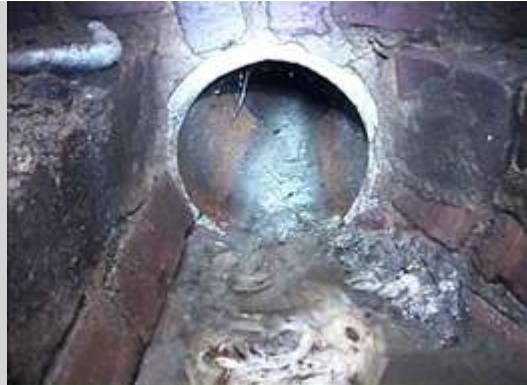
8 in. Circular Gravity Sewer Pipe Out @ 12 O'Clock

Pipe Material: **Clay** ☐ Pipe Lined

Invert Depth: **11.46** (ft.) Flow Characteristics: **Slow**

Deposits: ☒ None ☐ Mud ☐ Sludge ☐ Debris ☐ Grease

Infiltration: **None** Pipe Seal Cond: **Unknown**

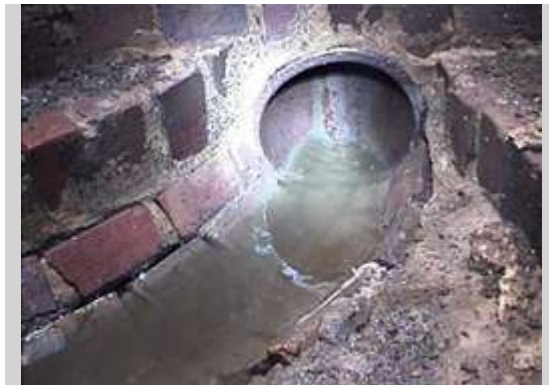
Drop In @ 3 O'Clock

Drop: **Outside** Rod and Bar
Angled: **Yes** Reading: **10.43** (ft.)
Inv Depth: **11.43** (ft.)

Drop Condition: **Open**

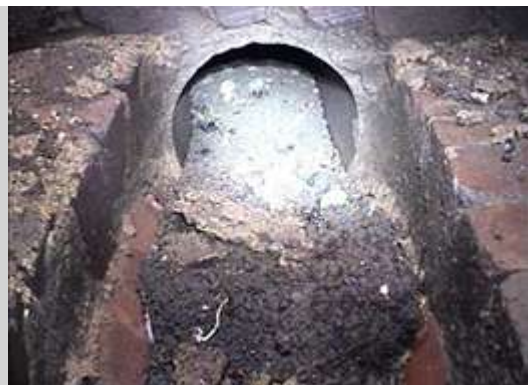
8 in. Circular Gravity Sewer

Pipe Material: **Clay**

Infiltration: **None**
